Thermal Patterns Created By Moisture Accumulation Within Exterior Masonry Walls

by A. Colantonio* and G. Desroches **

* *Public Works And Government Services Canada, Ottawa, Canada*

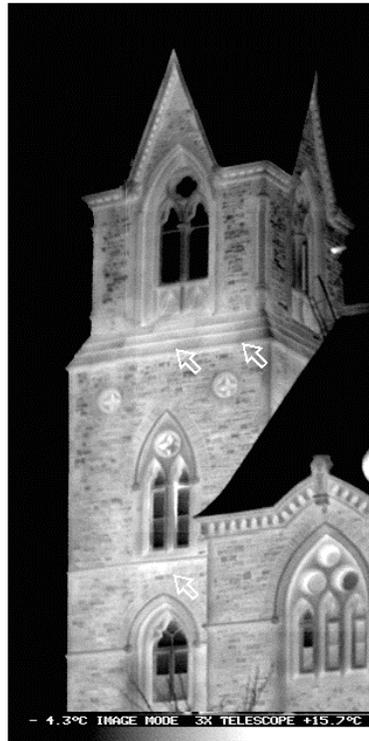
Fig. 1.

Building Pressure; 0 Pa, $T_o = -8^\circ\text{C}$, No precipitation or snowfall for at least 7 days prior to inspection. Arrows point to suspected moisture accumulation within the limestone cladding due to rain and melt water throughout winter months.

Rainwater penetration patterns are generally associated with the top section of walls and most likely around parapet walls. Unless buildings are located in areas with a high driving rain index, most building only experience rainwater penetration along the top floors. Other areas where rainwater penetration may occur are at sloped or protruding walls or drainage planes from upper wall sections. Windowsills and parapets are examples of such drainage features. Sloped relief details in stone masonry walls are another example of such conditions. (Refer to **Fig. 1**)

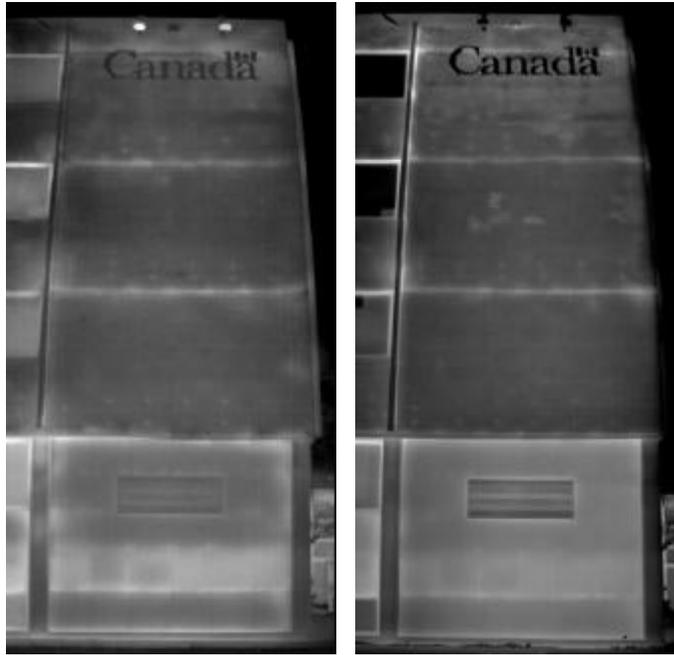
The two images below (**Fig. 2 & 3**) demonstrate the amount of moisture accumulation that can occur within masonry cladding as a result of stack effect brought on by winter exterior ambient temperatures. Both images taken during negative building pressures are void of air exfiltration patterns but **Fig. 3**, taken at a lower ambient temperature (-11°C), displays greater amount of moisture accumulation within the masonry cladding at the top of the building than **Fig. 2** taken at temperatures approximately 11°C higher.

Fig. 2.
Building Pressure (-140 Pa), $T_o = 0^{\circ}\text{C}$

Fig. 3.
Building Pressure (-8 Pa), $T_o = -11^{\circ}\text{C}$

The only other variable in **Fig. 2** is significantly increased negative pressure in the higher temperature situation that could have resulted in modification of existing moisture patterns. The increased negative pressure combined with the time prior to inspections may have reduced the amount of moisture within the wall cladding. In addition, due to reduced exterior ambient temperatures, stack effect would have been reduced for the period prior to capture of image in **Fig. 2**, thus reducing the amount of moisture especially at the top of the building envelope.

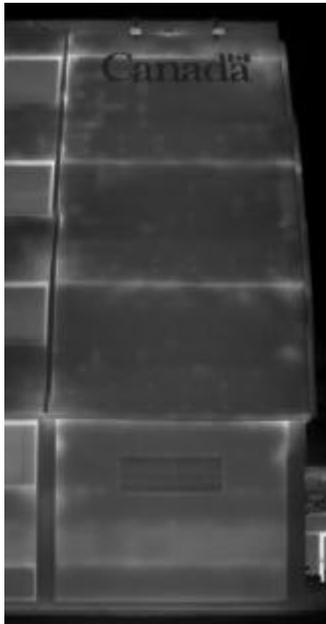
Fig. 4 & 5 demonstrate the amount of moisture accumulation that can occur within masonry cladding as a result of stack effect brought on by reduced exterior ambient temperatures. Both images, taken during positive building pressures, display thermal patterns created by air exfiltration in addition to previously accumulated moisture patterns due to stack effect pressures. Air leakage patterns appear warmer thus overpower moisture induced thermal patterns in both exterior ambient temperature conditions.

Fig. 5. taken at temperatures of approximately 11°C lower than **Fig. 4** illustrates greater amount of moisture accumulation within the masonry cladding *at the top floor*. This is consistent with thermal patterns produced during the negative building pressure inspections. The other variable in these images is the slightly increased positive pressure in the higher temperature situation (**Fig. 4**) that could have resulted in the slight modification of existing moisture patterns.

Fig. 4. Building Pressure (+40 Pa), $T_o = 0^{\circ}\text{C}$ **Fig. 5.** Building Pressure (+25 Pa), $T_o = -11^{\circ}\text{C}$

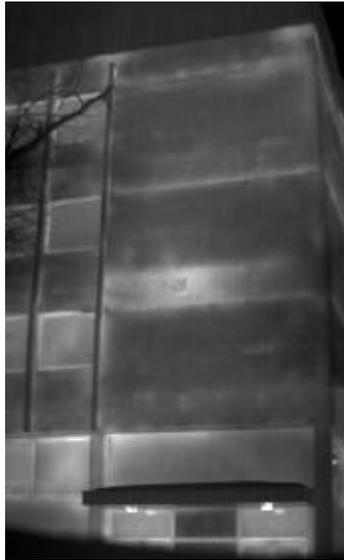
The thermal images seen in **Fig. 6 to 9** demonstrate the variances between moisture patterns created by both direct and diffuse air leakage. These images also illustrate the variations during both positive and negative pressure conditions during inspections.

Fig. 6.
Building Pressure (-140 Pa), $T_o = 0^{\circ}\text{C}$

When looking at buildings during cold weather conditions, variations in the thermal signatures created by naturally occurring weather conditions will take considerable time to be modified and in some conditions, may not be modified at all. In **Fig. 6 to 9** the masonry areas around the vent located in the central section of the third floor appears warm even in the negative pressure inspections even through negative pressures were imposed more than 2 hours prior to each inspection. Exterior ambient temperature seems to have little affect on the dissipation of stored heat and moisture within the masonry around these areas. Greater time is required under negative building pressure to eliminate the stored heat from air leakage within the masonry cladding due to intentional and unintentional wall openings.

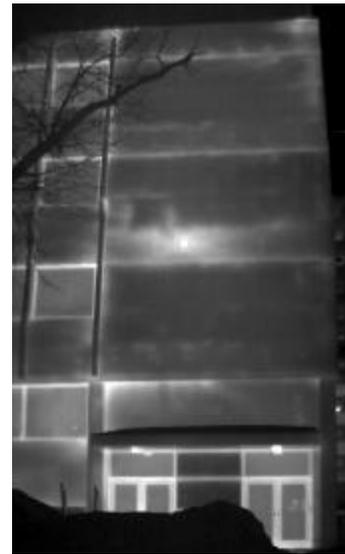
Fig. 7.
Building Pressure (+40 Pa), $T_o = -0^{\circ}\text{C}$

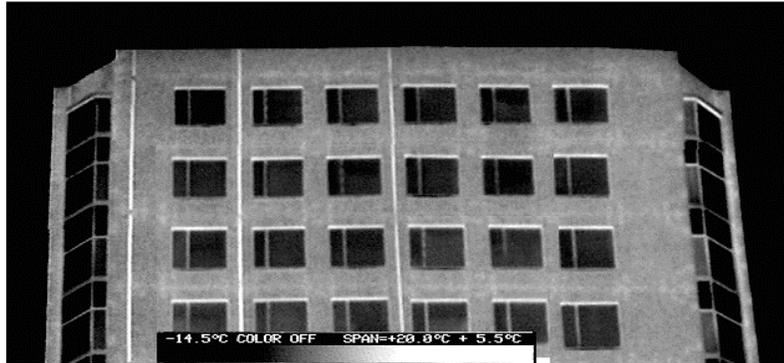
The composite thermal images in **Fig. 10 & 11** were taken on subsequent mornings. The positive pressure imagery (**Fig. 11**) was produced 24 hours prior to the negative pressure imagery in **Fig. 10**. The arrows at the parapet walls of this 24-storey building identify the moisture accumulation within the brick cladding as a direct result of positive building pressure imposed on the building for air leakage testing. These moisture patterns were not present prior to the positive building pressure being induced into the building and did not appear until after 4 hours of positive building pressure.

Fig. 10
*Negative Building Pressure (-60 Pa), $T_o = -7^{\circ}\text{C}$,
maintained for a duration of 4 hours prior to inspection.*

Fig. 10 illustrated the thermal imagery from the same area of this building while being subjected to negative building pressure the following evening. Thermal patterns due to air leakage are absent as are patterns created by moisture accumulation within the brick cladding at the parapet walls

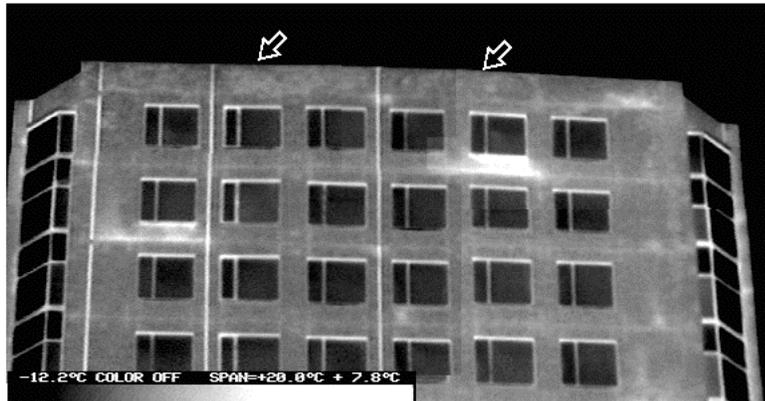
Fig. 11
*Positive Building Pressure (80 Pa), $T_o = -7^{\circ}\text{C}$,
maintained for a duration of 5 hours prior to inspection.*

In **Fig. 11**, leakage areas were random in various sections of the building and not widespread, but the sustained abnormal positive building pressure during testing did result in additional moisture migration from the building into the masonry cladding. This is a common occurrence in both solid as well as cavity wall assemblies. In cavity wall assemblies, moisture migration often travels from the source of the air barrier opening, up to the top sections of the wall cavity due to convection. Another factor that contributes to the increased build-up of moisture accumulation at top sections of buildings is the increased stack effect pressures generally found at these elevations during winter months and the lack of through wall heat flow at parapet walls.

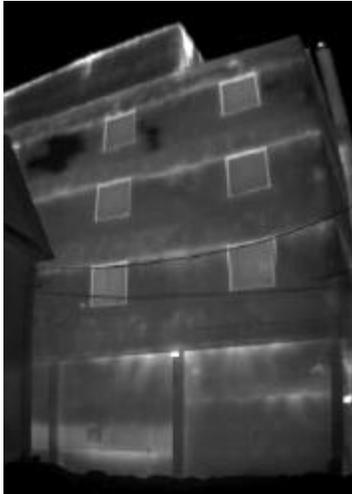
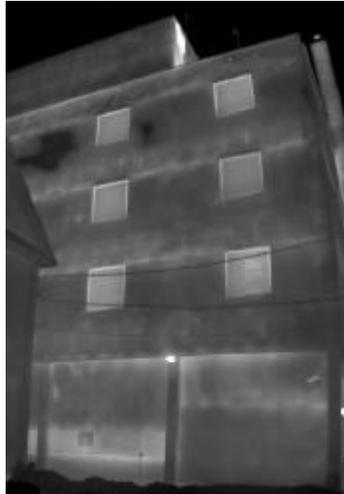
*Building Pressure (+40 Pa), $T_o = 0^\circ\text{C}$, Building Pressure (-140 Pa), $T_o = 0^\circ\text{C}$
Both images taken during same evening, 4-hour time span between the two images.*

moisture is visible through reduced surface temperatures as the frozen surface moisture freezes and thaws. This phenomenon occurs independent of either positive or negative pressures. **Fig. 12 to 15** illustrate this point.

The dark areas on the 4th floor masonry illustrate the thermal pattern generated by the phase change of masonry moisture. It appears reasonably consistent during both the negative and positive inspections during the same evening where freezing occurred.

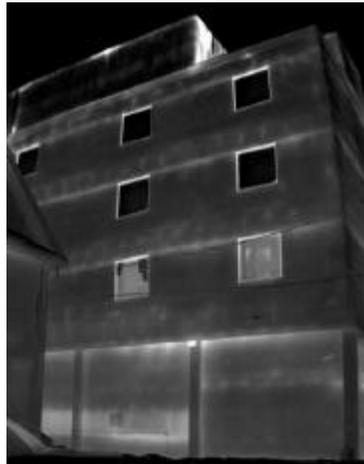
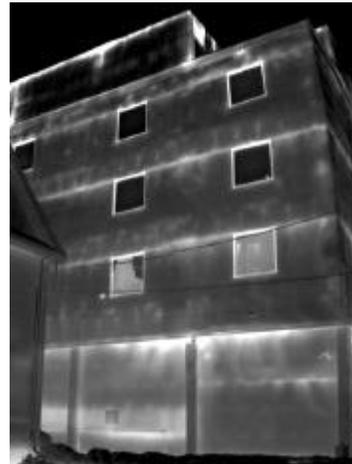
*Building Pressure (-8 Pa), $T_o = -11^\circ\text{C}$ Building Pressure (+25 Pa), $T_o = -11^\circ\text{C}$
Both images taken during same evening, 4-hour time span between the two images.*

Fig. 14 & 15 were taken during same evening with significantly sub zero outdoor ambient temperatures, 4 hours between the two settings. Due to the lower exterior ambient temperatures, phase change phenomenon is not visible. Moisture accumulation is visible during both inspections, but easier to detect and determine from air leakage patterning during negative pressure conditions than positive pressure conditions.
