Discovering the mysteries of the *Santa Maria di Collemaggio* Church (L'Aquila, Italy) by non-destructive testing techniques

by S. Sfarra*, A. Bendada**, C. Ibarra-Castanedo**, D. Ambrosini*, D. Paoletti* and X. Maldague**

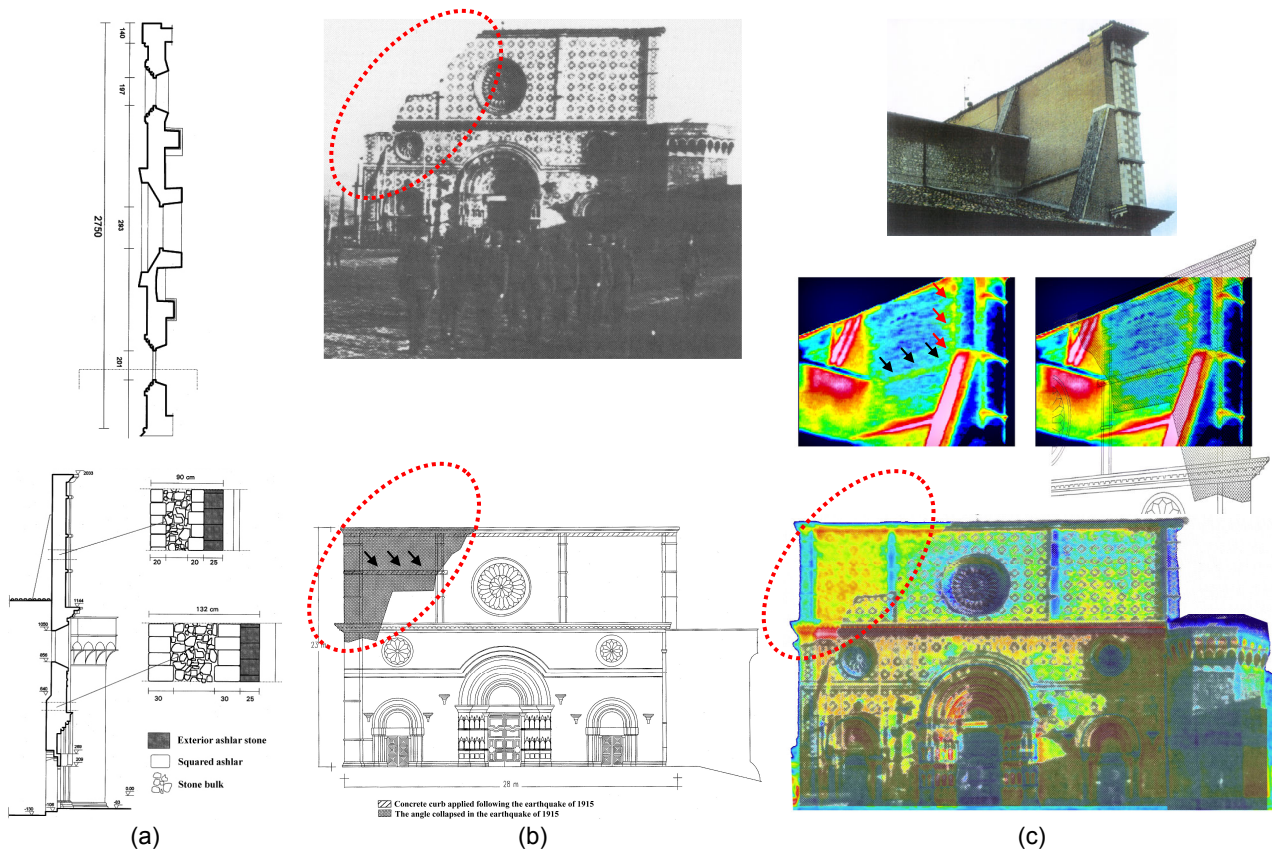
Its arrangement is not well defined. Basically, at least three leaves of different materials constitutes the wall (Fig. 1a). The actual facade is the result of at least two major structural interventions.

The first performed after the 1915's earthquake, which strongly damaged the upper left corner (Fig. 1b), consisted in a reinforced concrete grid and a leaf of brick masonry at the rear of the facade to improve its resistance out of plane. In order to confirm this, Figure 1c shows the thermographic results as passive approach and the superimpositions with the visible images. Furthermore, this reinforcement was stiffened by means of four vertical brick corbels laying on longitudinal walls. The second performed in 1972: the Baroque superstructure was removed from the main and side aisles, and the ancient octagonal columns and the pointed arches were brought to light [15].

Fig. 1. (a) plan and section of the main facade, (b) picture and sketch of the main facade after the 1915's earthquake with the structural reinforcements adopted (black arrows), (c) thermograms and image fusions: note the known buried structure detected from the rear side of the facade by IRT (black arrows), and unknown (red arrows) as well as the different "thermal imprint" of the reconstructed part of the facade (red dashed oval).

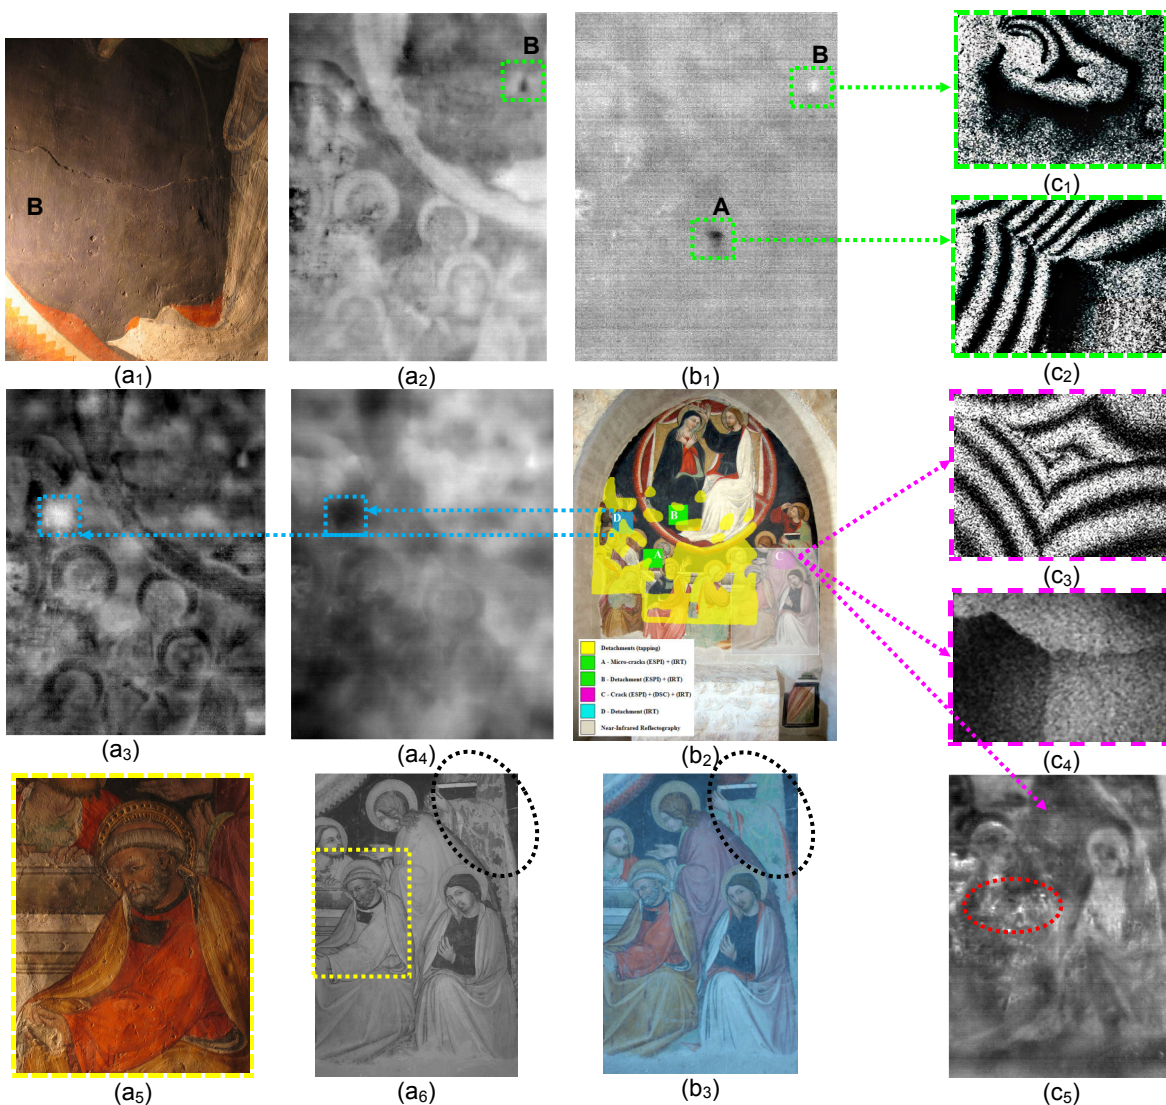
The fresco studied is shown in Figure 2b₂, which also includes the defects map identified with the various non-destructive testing techniques described above.

Fig. 2. (a₁) raking light result of the defect B, (a₂) PCT-EOF2, (a₃) phasegram $f=0.002$ Hz, (a₄) PCT-EOF1, (a₅) raking light result of the sub-superficial signs, (a₆) NIR result, (b₁) PCT-EOF7 (first sequence), (b₂) “Incoronazione dell’Assunta” fresco and defects map, (b₃) visible image, (c₁), (c₂), (c₃) ESPI results of the defects A, B, C, (c₄) Speckle decorrelation result, (c₅) PCT-EOF7 (second sequence)

Figs. 2c₂, c₁, c₃ are relative to correlation fringes of three different zones of the fresco where were identified respectively the A, B, C defects (Fig. 2b₂); as stress mode we utilized ambient temperature variations ($\Delta T = 4^\circ\text{C}$). The presence of a subsurface cracks (Figs. 2c₂, c₃), identified by the abrupt interruptions of the interferometric fringes, was revealed using an out-of-plane sensitive configuration of the ESPI system [22]. The profile of the cracks can readily be deduced by the location of fringe discontinuities in the image. Speckle decorrelation (Fig. 2c₄ – defect C) is simpler and less sensitive than ESPI but able to detect different movements of the surface; in order to prove this, the technique has been applied in conjunction by ESPI technique for the same defect.

Another interferogram (Fig. 2c₁ – defect B) also revealed the presence of a sub-superficial detachment. A raking light result (Fig. 2a₁) shows that there is a swelling of the paint just below the crack marked by white arrows in Figure 5a.

Very interesting to note the difference in terms of colour between the PCT results reported in Figs. 2a₂ (dark spot – EOF2) and 2b₁ (light spot – EOF7) inherent the defect B, as well as between the phasegram in Fig. 2a₃ (light spot) and the PCT-EOF1 (dark spot) inherent the defect D. Both defects are related to sub-superficial detachments, as confirmed by tapping (Fig. 2b₂). Therefore, the integration between ESPI technique and thermographic technique, it is extremely useful: with the first, the fringes's curvature suggests that there is a detachment or a crack beneath the surface, while with the second this is given by the color's difference after the PPT and PCT data processing [51, 52, 53]. If these techniques are used together and combined with the traditional and qualitative coin tap test, the probability of false alarms is substantially reduced.

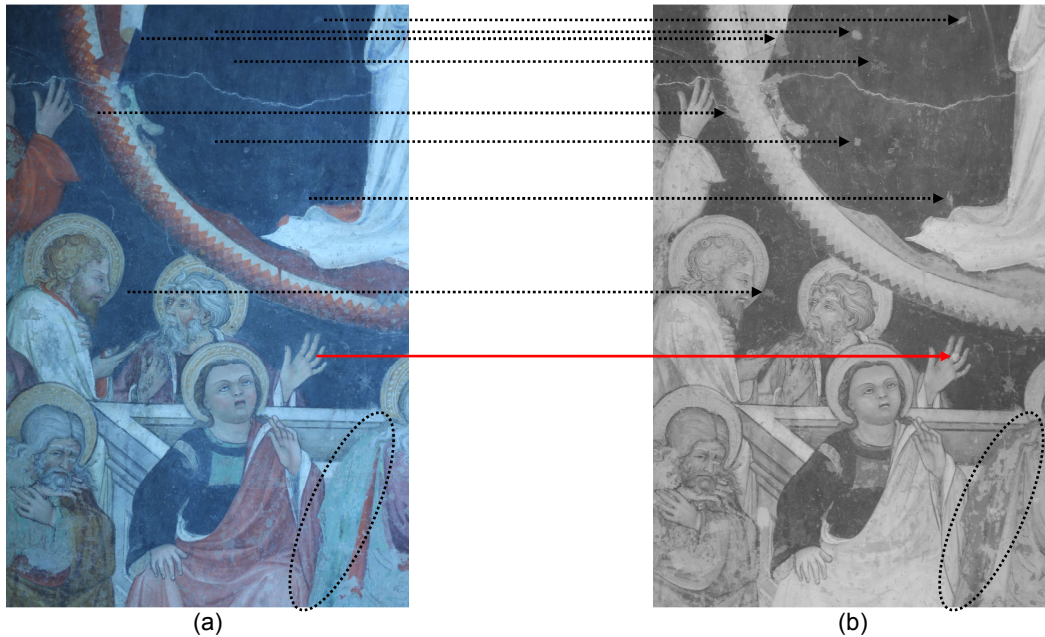
The painting decay, allows to see under a colour a different hue. This is somehow similar to the NIR inspection shown in Figs. 2a₆ and 3b. A CMOS camera (Canon 40DH 22.2 x 14.8 mm – 10 megapixel 0.38-1.1 μm), with a visible cut-off filter to limit the spectrum to 0.7 to 1.1 μm was used. The radiation source, consisted of 1 halogen lamp (STAR Progetti – 2 KW IR), which provide a wide spectrum radiation (including the NIR band).

Fig. 3. (a) visible image, (b) NIR result

Very interesting to note, several paint repairs highlighted with dotted black arrows, the large preservation works that have been made on both mantles of personages highlighted with a black dashed oval in Figs. 2a₆, 3b, and an intriguing retouch done on the middle finger of the left hand of the character depicted in Figure 3a, marked with a red solid line. Furthermore, a surprising detection of three signs beneath the orange and ochre mantle of the character shown in Fig. 2b₃, was obtained by PCT (Figs. 2c₅, 4a) highlighted by a red dashed oval. The same signs are engraved on a stone preserved in the Church and are included in Fig. 4b for comparison.

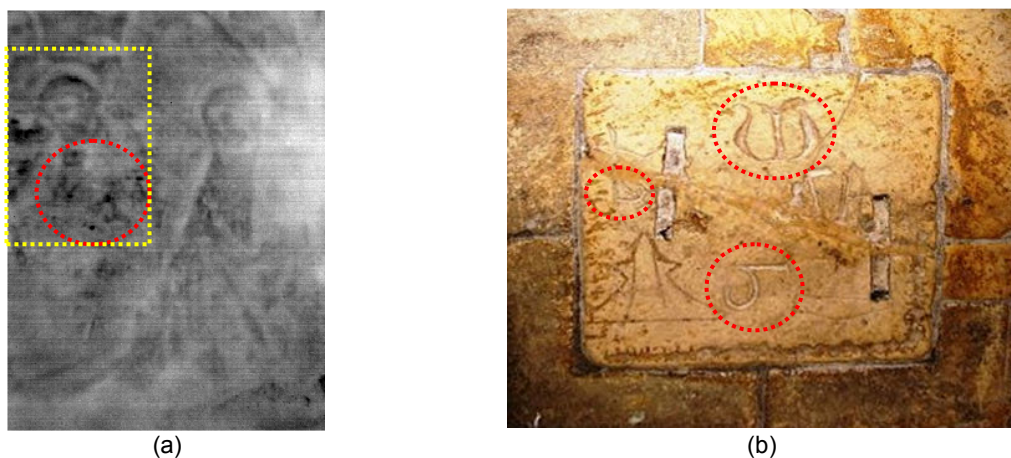
Fig. 4. (a) PCT-EOF5, (b) stone preserved in the Santa Maria di Collemaggio Church

At this point, a first possibility that could provide an explanation, is that these *graffiti* are to be attributed to different periods, and that they are the signs of the builders who worked during the Church's construction. Fig. 5c, obtained by method of Otsu, explains the nature of the signs detected by PCT as *graffiti* [47]. In fact, these signs resemble gothic letters, and appear to be sub-superficial since they were not identified by neither the raking light result reported in Figure 2a₅, nor the NIR inspection image in Fig. 2a₆.

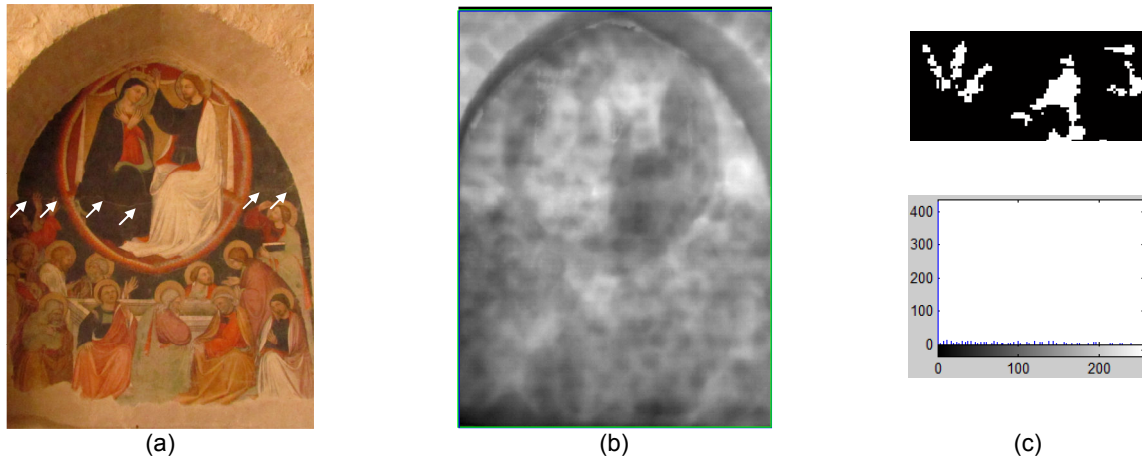
Fig. 5. (a) visible image, (b) PCT-EOF1 result (third sequence), (c) Threshold text by method of Otsu and histogram of the original image

Furthermore, observing the fresco, it is possible to note a superficial and horizontal crack that separates it in two parts as indicated with the white arrows in Fig. 5a. As said above, the stability of the wall is critical to the painting deformations induced by external factors [48, 49]. The presence of this crack can be explained, observing and comparing the visible image and the PCT-EOF1 result (third sequence) shown in Figure 5b. Readers can see as the stones texture which constitute the wall, is aligned vertically above the crack, and transversely below. This lack of structural homogeneity, could have produced the superficial crack during the 2009 earthquake's or before. Taking that into consideration, in addition to the fact that the paint is very dense and superimposed in several layers, and in percentage terms the detachments detected by tapping are mainly distributed below the crack (Fig. 2b₂), a second possibility is that the *Incoronazione dell'Assunta* fresco was painted above another fresco (previously produced), and it ended up with this crack. This would explain the nature of the three gothic signs identified, namely the artist's signature of the original fresco, which were not detected by NIR technique because of the paint's thickness and/or composition. Moreover, the niches where are located the frescoes are of different shapes, placed at an irregular distance and completely unrelated to the rhythm of the bays [50]. This assumption is also connected to another thermal anomaly relative to a niche of the same Church; the thermographic results as passive approach are reported in Figure 6.

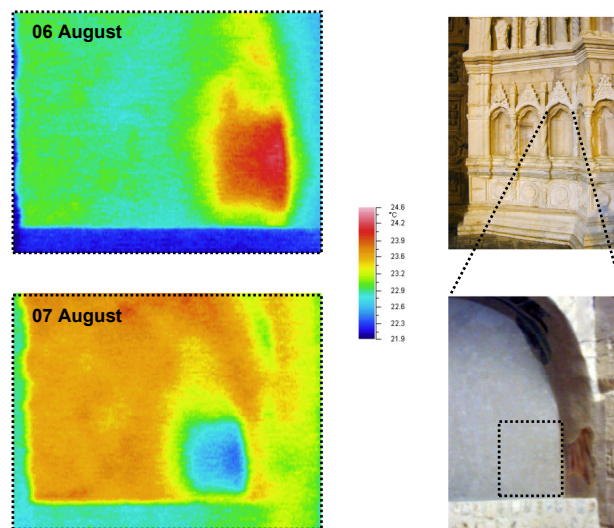
Fig. 6. IRT results for a niche located inside Santa Maria di Collemaggio Church

Data were collected on two different days and with opposite thermal gradients (one thermogram acquired close to sunrise, the other close to sunset). The result is the same, namely the detection of a buried structure covered with plaster. In this case, the passive approach was sufficient in order to obtain a clear result, instead for the *Incoronazione dell'Assunta* fresco it was necessary the active approach consisted of one 2 KW halogen lamp.

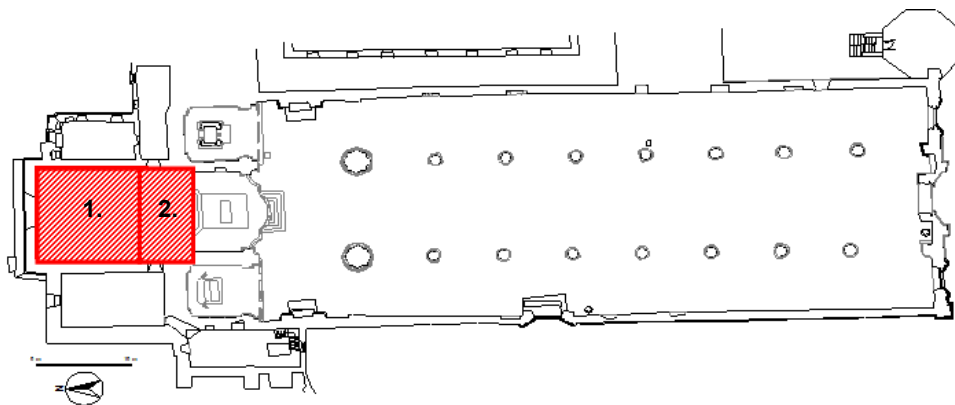
Fig. 7. Floor map of the Santa Maria di Collemaggio Church and identification with red rectangles of the areas where the Ground Penetrating Radar (GPR) technique was carried out

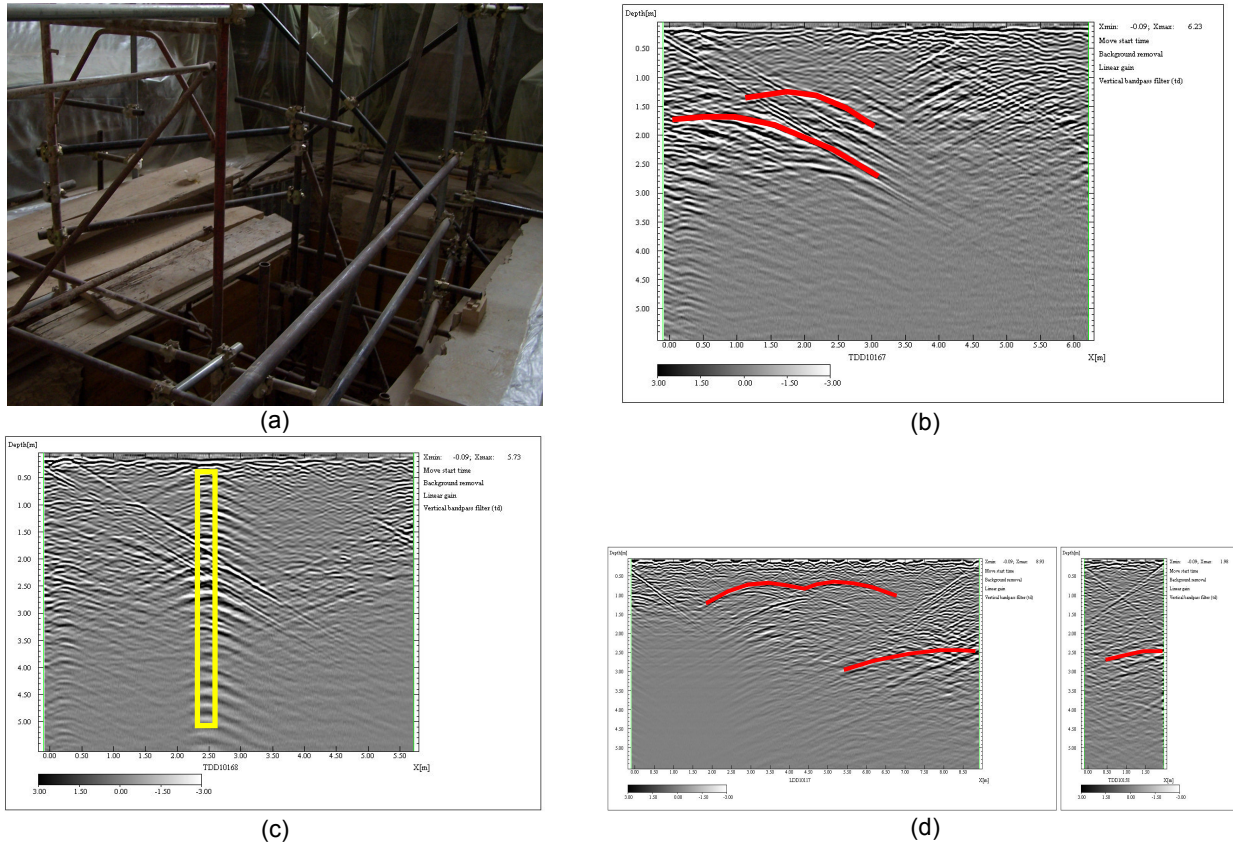
In fact, for both zones is evident that the discontinuities detected are attributable to two types of targets: a) a distributed anomaly with sub-horizontal trend related to the ground-air gap: in this case the target represents the vaults of the cavity and its thickness settles around 1.5 m below the floor (Fig. 8b); b) an abnormality vertically localized, to be attributed to the presence of a vertical wall (Fig. 8c). In the second grid, there is a deep anomaly distributed, around 2.5 m below the floor and with a not regular geometry. The second target is also distributed and rather shallow, about 0.70 m deep, but geometrically well-defined (Fig. 8d).

Fig. 8. (a) Excavation's picture carried out after the GPR surveys (b) Radargram of the first grid: example of distributed anomaly, (c) Radargram of the first grid: example of localized anomaly, (d) Radargram of the second grid: example of distributed anomalies.

Indeed, excavations (Fig. 8a) have uncovered the walls below the Church's floor, which testify the presence of secret underground rooms.
