Wide-Area Impact Damage Evaluation with Sonic Infrared Imaging NDE in Advanced Composite Structures

- by X. Han*, Justin M. Ar-Rasheed*, D. Zhang*, A. Lubowicki*, L. Favro**, and G. Newaz***
- ^{*} Department of Electrical and Computer Engineering, Wayne State University, Detroit, MI 48202, USA, xhan@eng.wayne.edu
- ^{**} Department of Physics and Astronomy, Wayne State University, Detroit, MI 48202, USA
- Department of Mechanical Engineering, Wayne State University, Detroit, MI 48202, USA

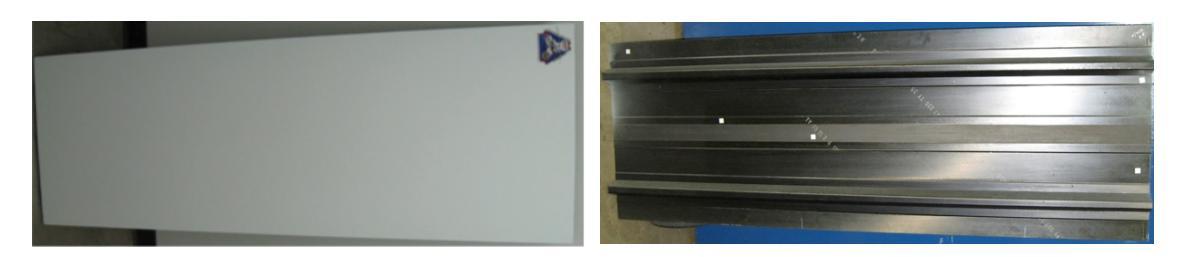
Figure 1. Photos of a composite panel's front and back side. The panel is 152cm long and 54cm wide.

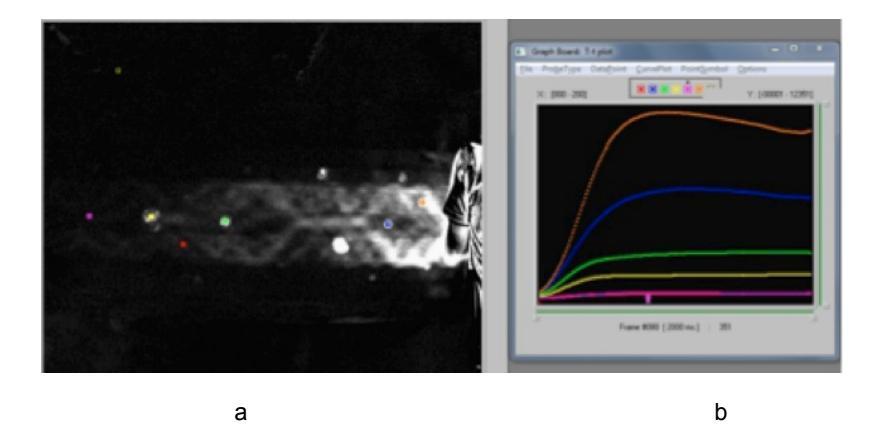
Figure 2a is a Sonic IR image of the panel showing the impact damage detected with the 20kHz 0.8 second ultrasound sound pulse injected at the right side edge of the panel. The image shows several impact damages underneath the top layers. In addition, temperature time plots over six selected impact damage spots are shown in Figure 2b. These data can be used to determine how much the signal from any damage rose above the background and can be used for quantitative evaluation of impact damages.
