## Non-destructive analyses of defects and effects of airborne pollutants in historical buildings

C. Bonifazzi<sup>a,e</sup>, G. Maino<sup>b</sup>, S. Massari<sup>b</sup>, L. Roversi<sup>b</sup>, C. Selvatici<sup>c</sup> and A. Tartari<sup>d,e</sup>

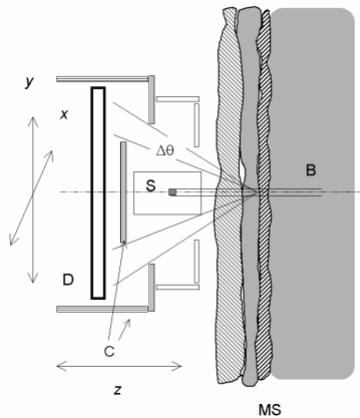
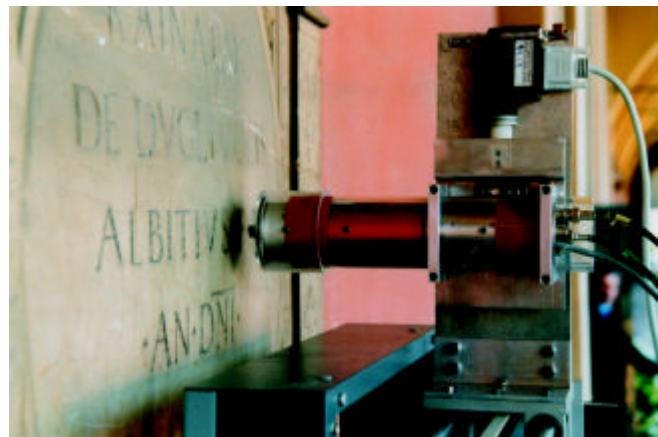
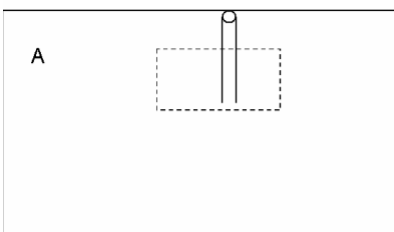
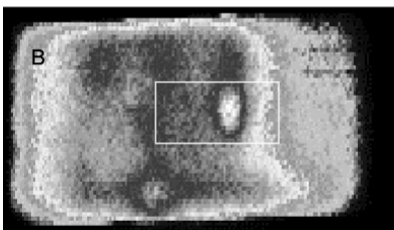
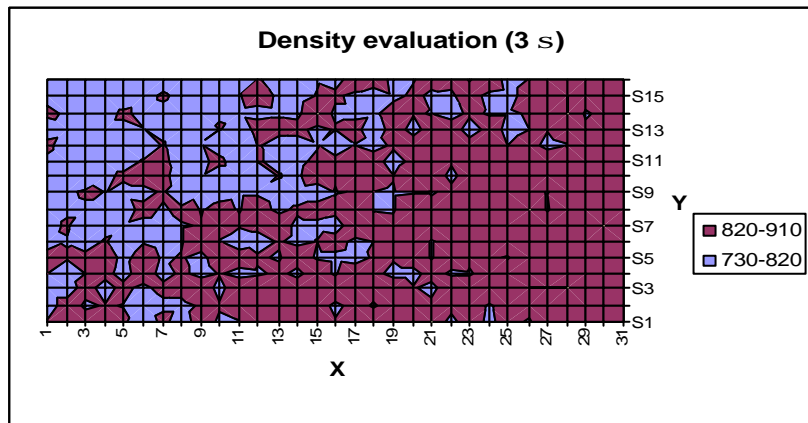
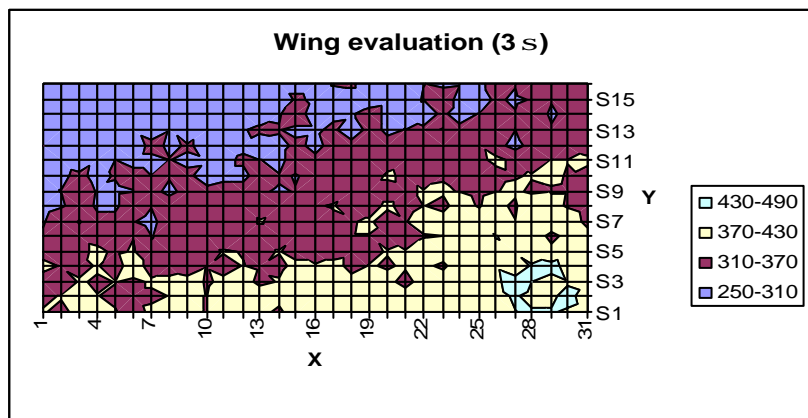
We based our investigation on multispectral techniques ranging from infrared reflectography, digitag thermography and ultraviolet fluorescence. In addition, an original portable equipment based on the detection of Compton scattering photons and a further statistical analysis of the collected data has been utilized. The photon detection has been performed by the Enhanced Compton Spectrometer (ECoSp), a recently devised instrument that allows to collect the backscattered photons by investigating the tested sample from one side only. Photons collected during the planar scanning of a given area are used to describe the electronic density of the sample as a density image; afterwards, the Principal Component Analysis (PCA) was applied to the multispectral image processing, resulting from the mathematical combination of all the adopted imaging techniques. As a case study, a non-destructive testing of plaster substrates supporting mural paintings has been performed using this technique, searching for flaws, defects, fractures, and so on. Results are shown in the following figures in comparison with usual termographic analyses.
