DIFFERENTIATED DEGRADATION BY VARIABLE ENVIRONMENTAL EXPOSITION: the case study of instrumental diagnostics for Cemetery Church in Messina-Sicily- Italy

by A. Bianco

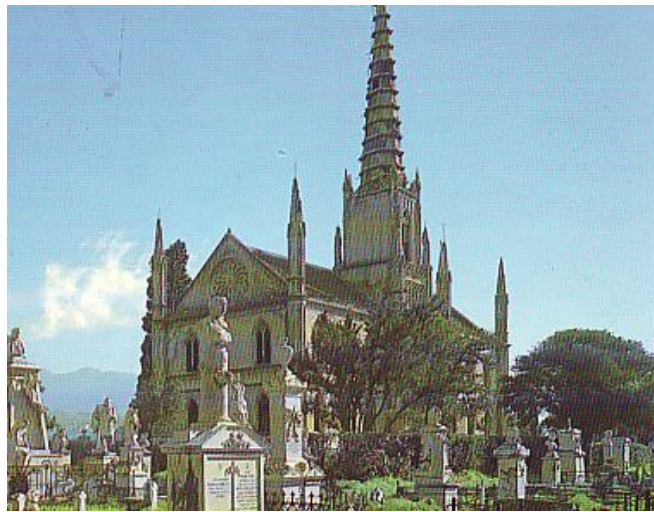
Fig. 1. Cemetery church of Messina, 2010

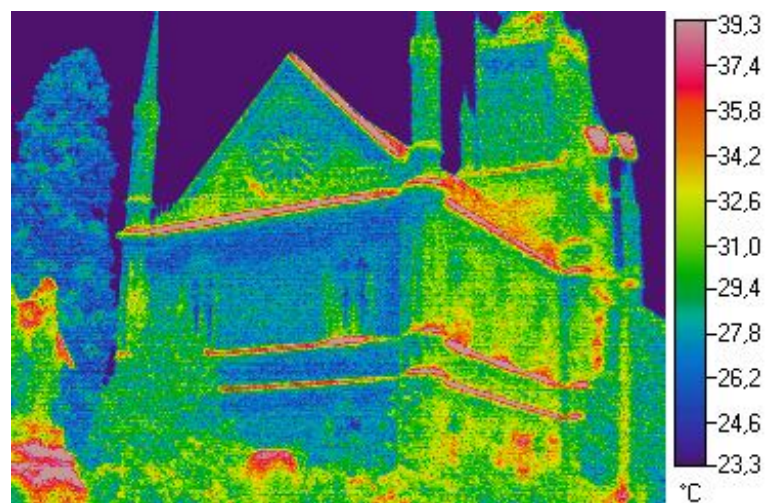
Fig. 3. Cemetery church of Messina, TI investigations

The investigative campaign has seen first of all realization of a dense thermographic mapping for every façade, showing in the North façade, as usually, a perceptible variation of hygrometric content and of thermographic flow. So, it were realized some direct instrumental investigations, finalized to value material and technological conservative conditions of materials, using the SonReb method (ultrasonic investigation and Schmidt hammer test) in peculiar points of reinforced concrete frame and of brick masonry, defining an evident denial of thermographic analysis. In fact both qualitative and quantitative results of material investigation show a particular degradation of the façade positioned in front of sea, that is at same time exposed to sea-aerosol and to strong winds and a better performance of brick in comparison with reinforced concrete, giving some element of evaluation, useful for consequent phase of structural and conservative project (figures 1-3).
