## Thermal mapping for detection of inhomogeneities in asphalt bridge decks

by H. Lorenzl\*, M. Wistuba\* and J. Grönniger\*

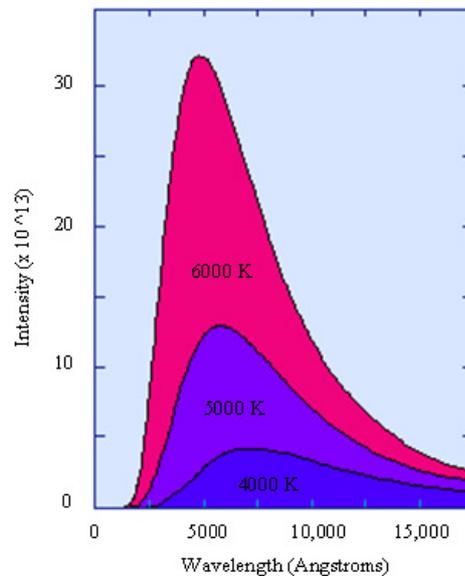
The Planck Law gives a distribution that peaks at a certain wavelength; the peak shifts to shorter wavelengths for higher temperatures (figure 1).

**Fig. 1.** Distribution of wavelength and intensity of radiation according to Planck's Law

Expressed by the Planck Law, all heated objects emit a characteristic spectrum of electromagnetic radiation, and this spectrum is concentrated in higher wavelengths for cooler bodies. Two other useful radiation laws can be derived from Planck's Law. The integration of (1) gives the total energy emitted at all wavelengths (area under the curves in figure 1) and is known as Stefan-Boltzmann Law:

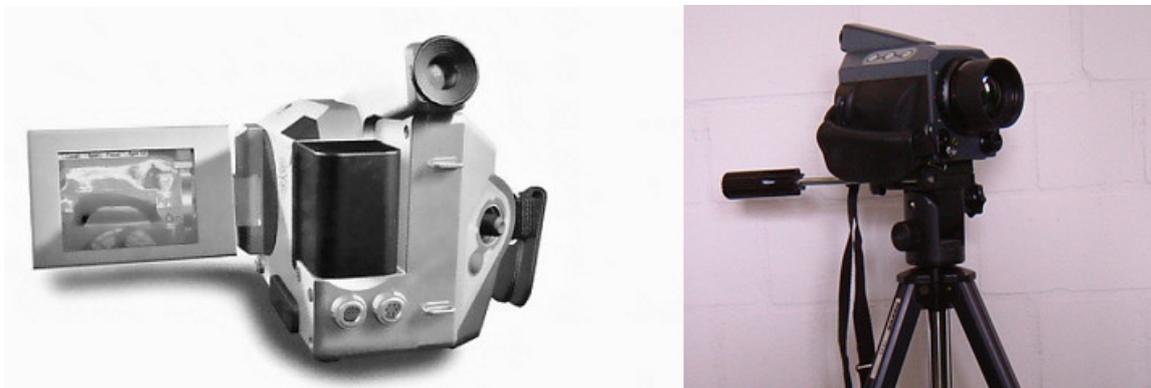
The portable thermographic system VarioCAM® hr for long wave infrared spectral range of 7.5 to 14  $\mu\text{m}$  was used for damage analyses. The lens images the object scene onto an uncooled microbolometer Focal Plane Array detector at a resolution of 384 x 288 pixels. Temperatures can be measured in a range of -40 to 1200°C with a temperature resolution of 0.1 K and measurement accuracy of 1.5 K (0...100)°C. A standard lens with a focal length of 25 mm, a minimum focus of 0.3 m and an Instantaneous Field of View (IFOV) of 1.4 mrad was used.

Fig. 2. Portable thermographic test equipment

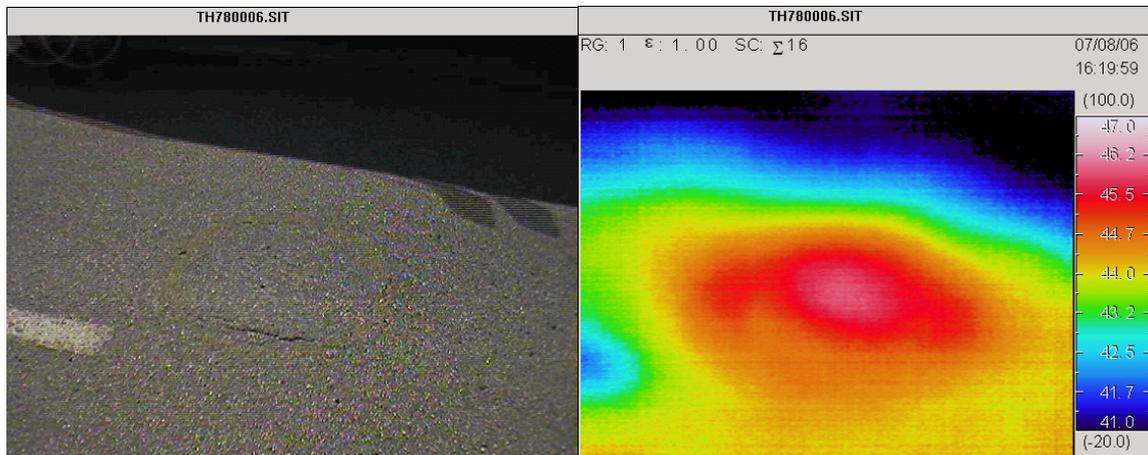
If blisters reach a certain size, it is possible to detect the damaged spots on the surface by a bulge or, due to traffic loading, caved in blisters in connection with initial cracks. Figure 3 shows a damage spot which was detected by visual examination. As the IR-image of the same spot clarifies, the area of the damaged spot (red coloured) shows higher temperatures on the surface compared to the surrounding area. The difference is about 3 Kelvin and the dimensions of the damaged spot are clearly visible.

**Fig. 3.** Blister, on the pavement's surface (left), detected by the IR-image (right).

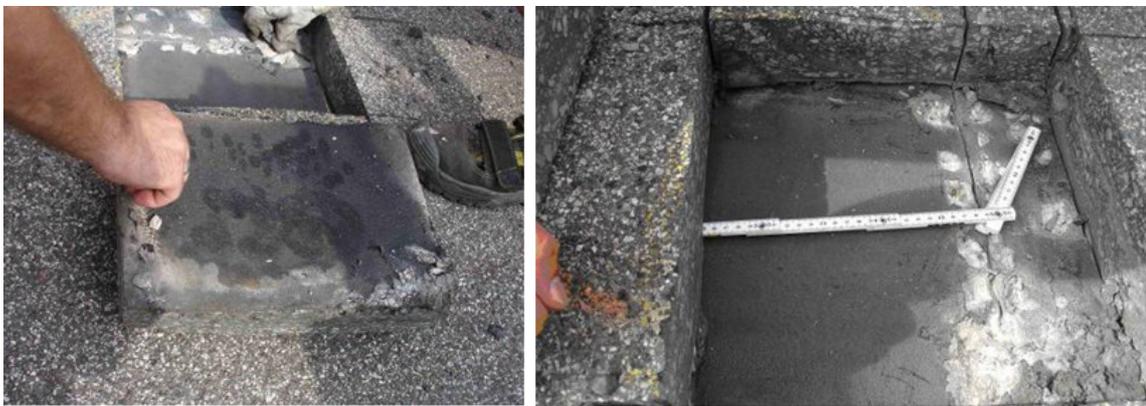
In order to verify the damage, the spot was opened and bonding between asphalt-sheeting and wearing course was checked (figure 4). The pavement was sawn under dry conditions. The asphalt-sheeting showed wet spots underneath. As demonstrated in the figure by the ruler, the bonding between the concrete base and the asphalt-sheeting is missing completely. Regarding the colour and structure of the sheeting it was concluded that it has not been flamed properly before. The dimensions of the damaged spot fit well with the observations by the IR-image.

**Fig. 4.** Opened damaged spot, detected by IR-image before (figure 1); lack of bonding demonstrated by means of a ruler.

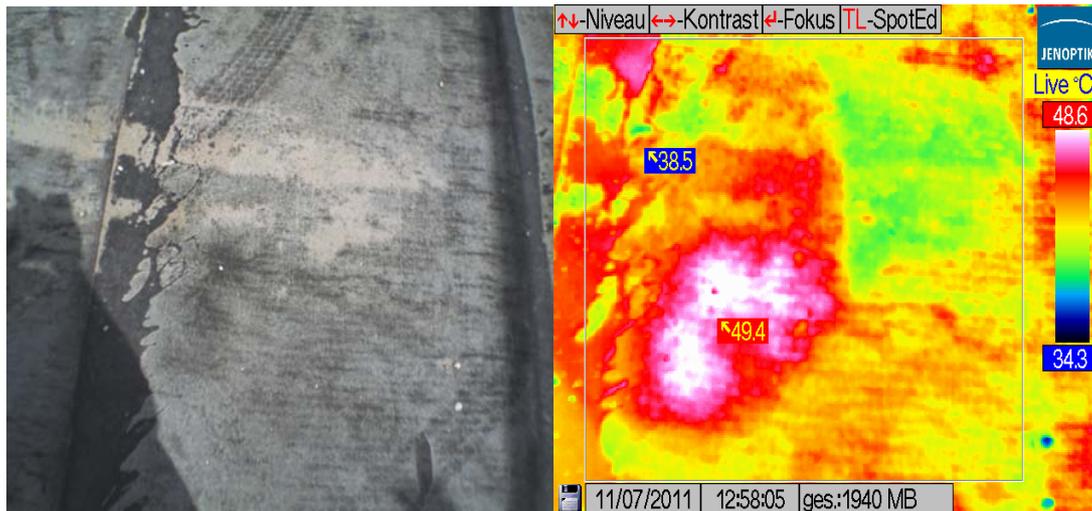
Figure 5 illustrates an example of an asphalt-sheeting on a deck without any damage on the surface. Visual examination leads to the assumption of accurate bonding. However, IR-image indicates a lack of bonding. The blister shows a higher surface temperature.

Fig. 5. Blister, on the pavement's surface (left), detected by the IR-image (right).

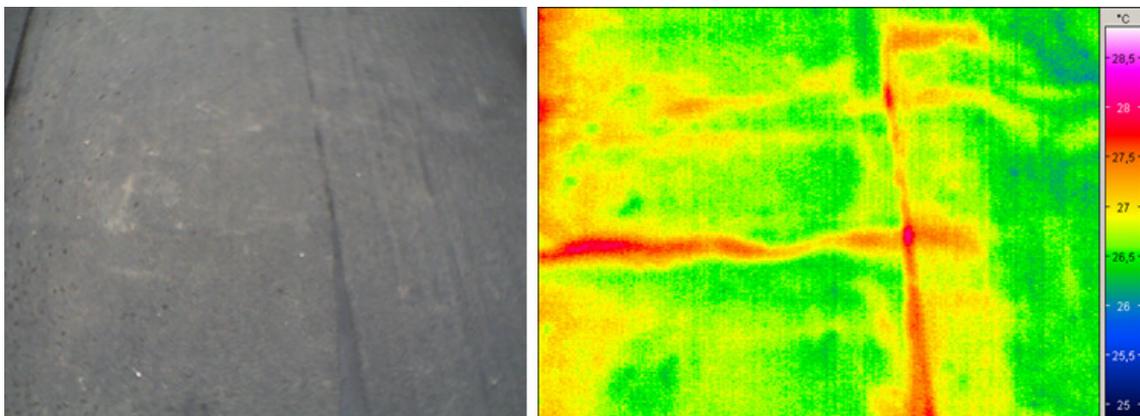
Figure 6 shows the same type of damage. The IR-image indicates a lack of bonding in the middle of the left asphalt-sheeting, running diagonally to the weld. The weld by itself shows a higher surface temperature due to its darker color and higher thermal capacity. On the one hand, this example points out that the thermal capacity of the individual building materials have to be considered when areas of higher surface temperatures are assessed. On the other hand, lack of bonding can be clearly visualized by means of thermography.

Fig. 6. IR-image shows missing bonding between asphalt-sheeting and base; no damage on surface detectable.

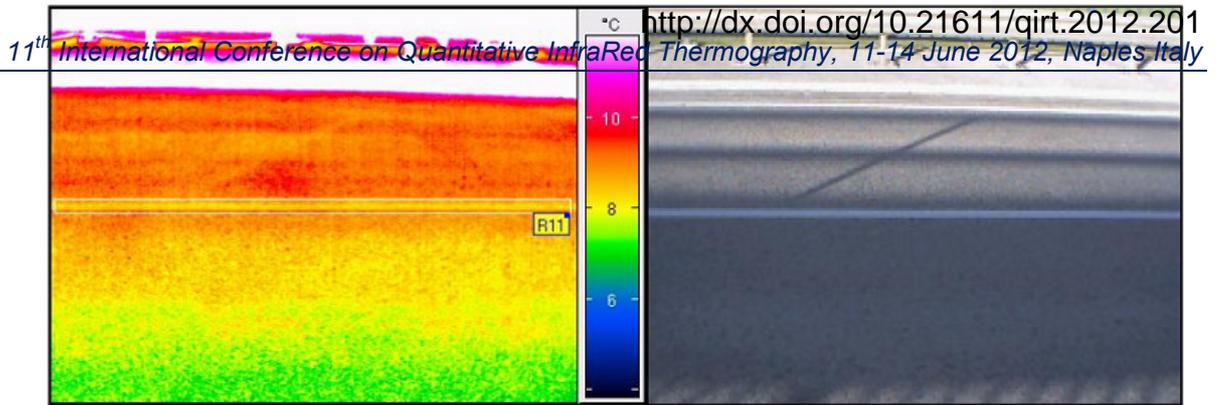
In order to measure the surface temperature precisely the emission coefficient  $\epsilon$  needs to be adjusted to the material characteristics. In figure 7, the influence of  $\epsilon$  on the surface temperature is presented.

At first sight, the crash barrier and the concrete verge in the upper part show higher temperatures (up to three degrees) compared to the pavement. As a result of lighter shading, the crash barrier and verge have a higher reflectivity and therefore a lower emissivity than the pavement. For determining the precise surface temperature the emission coefficient of that area needs to be adjusted to e.g. 0.8 compared to 1.0 for the pavement. As the crash barrier is of no interest for assessing the bridge decks quality,  $\epsilon$  was set to 0.85 only for the area marked as "R11" (road marking). The effect of the adjustment is negligible, as the surface temperature of the road marking is increased by only 0.3 °C. Even without any adjustment of  $\epsilon$ , a lack of bonding underneath the road marking would be noticeable by a temperature difference.

**Fig. 7.** Influence of the emission coefficient on the surface temperature.

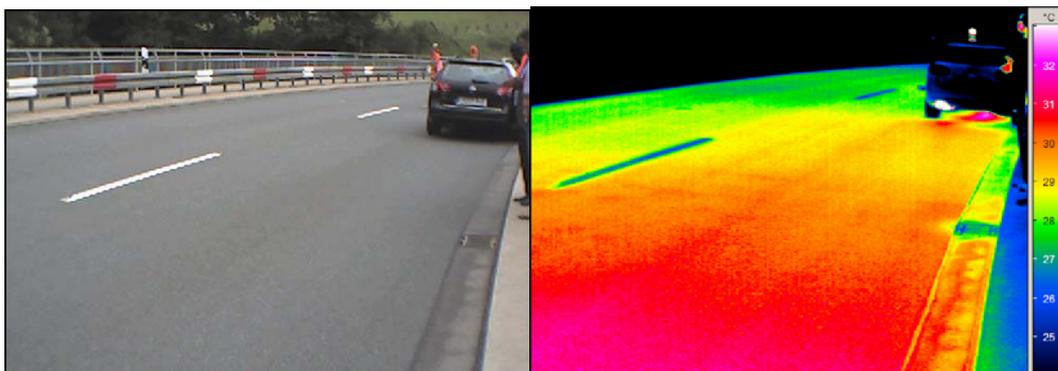
Another effect on the surface temperature can be seen in figure 8. The front area seems warmer than the back, which is due to the different angle of the camera position.

**Fig. 8.** Influence of the camera position / angle on the detected surface temperature.

Depending on the camera position, the surface temperature of a defined area (yellow) can vary up to 1.3 °C as tests have shown (Schwarz 2008) (figure 8). It is therefore recommended, to align the camera orthogonal to the surface. The influence of varying angles is thereby eliminated.

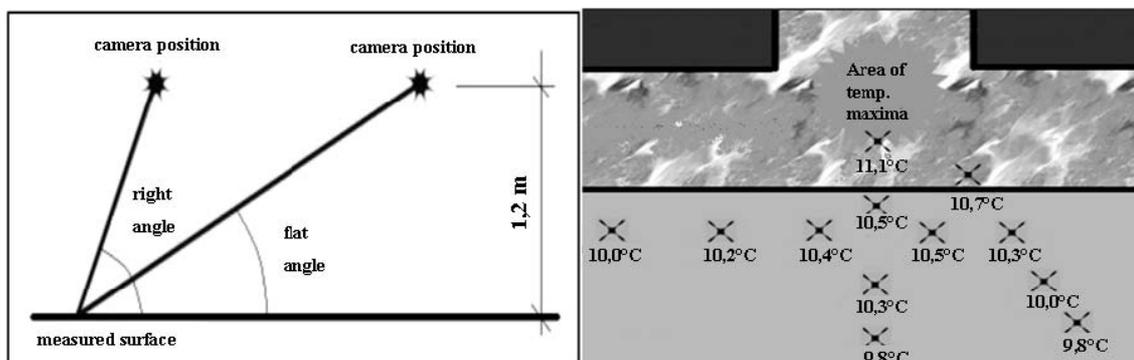
**Fig. 9.** Influence of the camera position / angle on the detected surface temperature (Schwarz 2008).

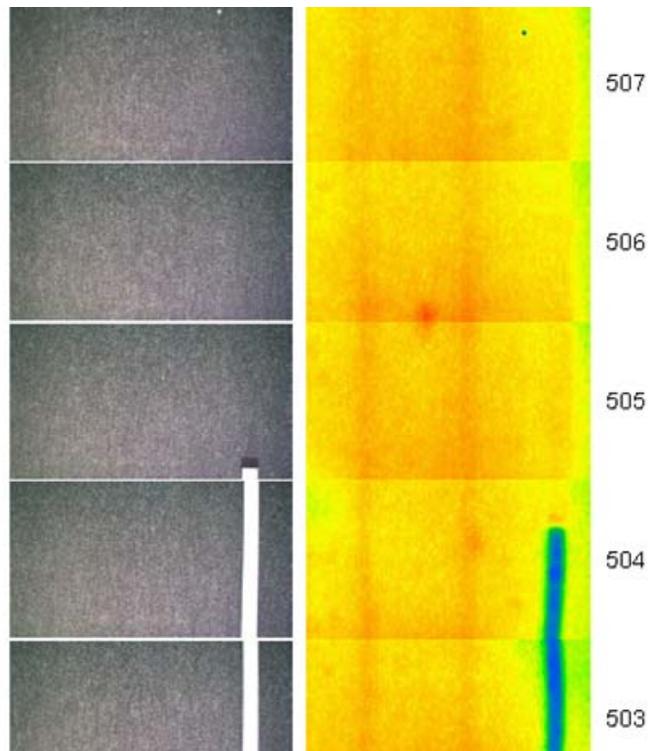
Figure 10 indicates the effect of overlapping of various asphalt sheetings. Visual inspection shows a proper surface, while thermography shows regular attendance of parallel bands with higher surface temperature. They refer to overlapping area between asphalt sheetings under asphalt overlay. This can be explained by the different thermal capacity of the overlapping area with dark bitumen compared to the rest of the asphalt sheeting.

**Fig. 10.** Thermal effect of overlapping asphalt sheetings.

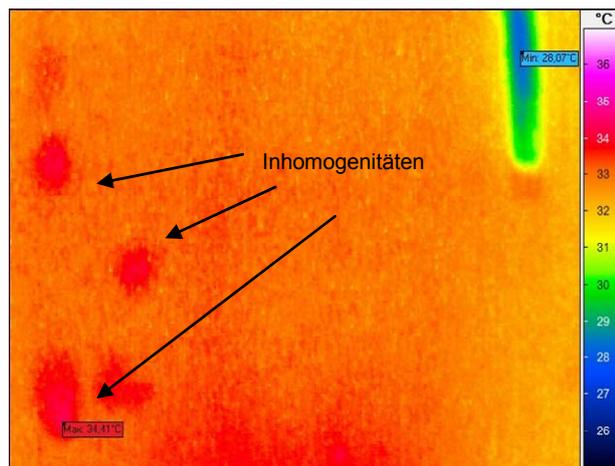
Inhomogeneities can be selected on the detected surface temperature and on local narrowness, see figure 11. Higher surfaced temperatures (red colour in figure 11) at about 3 K indicate the position of inhomogeneities.

**Fig. 11.** Local narrowness of inhomogeneities.
