## Civil engineering structure daily monitored through IR Thermography and environmental measurement.

An integrated infrared measurement system synchronized with weather parameter measurements developed to make long term thermal monitoring of structural elements over a year is presented. The software and hardware architecture has been designed with the aim to be fully autonomous. Twin reinforced concrete beams, a damage one and a healthy one, are surveyed with this system. This study presents results obtained during the first six month of monitoring. Results obtained are detailed and discussed. A comparison with thermal measurements carried out inside the healthy beam is also proposed and discussed by comparison with external measurements.

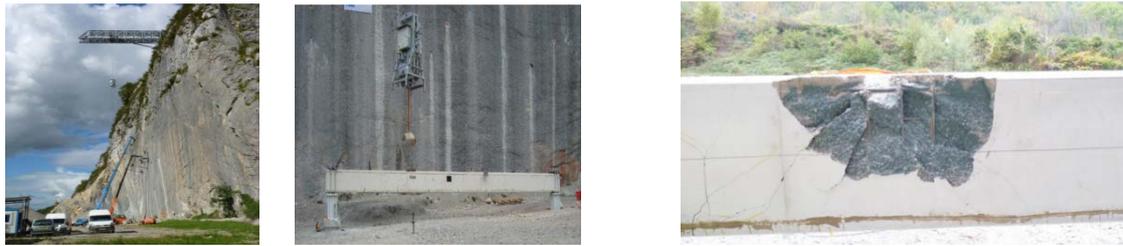
**Fig. 4** IFSTTAR falling block test station (left), load of 2.5 T used (center), impact view (right)

Its twin sister has been damaged by several mechanical impact of high energy at the IFSTTAR falling rocks test station located in the French Alps (see figure 4). To damage this beam, a 2.5 tons steel ball has been dropped on the concrete beam from various heights. A total of four mechanical impacts have been carried out on the upper face of the beam, three from a height of one meter and one from five meters [9]. The figure 4 right present the damage generated on the top of the beam at the end of the experiment.

The impacted area presents, in the rear face of the beam, a leaving of materials that allow to see the rebars. Analysis of the rebar positioning after each impact was presented in [9]. After this mechanical experiment, this damage beam was moved back from French Alpes to Nantes and placed behind and parallel to the longitudinal axis of its instrumented twin. The long term monitoring system was then set-up at this IFSTTAR large scale testing facilities in Nantes (see figure 5).

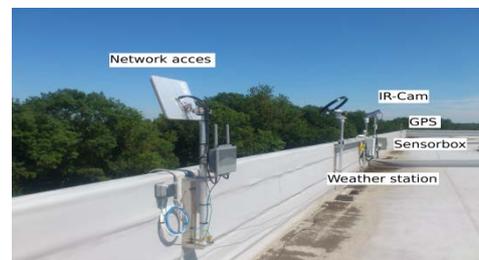
**Fig. 6** Schematic view of the system and the roof layout

The infrared camera is placed in a thermally controlled caisson in order to protect it and insure a minimal temperature during the cold season. The front case is constituted of an optical adapted IR glass (with high transmission coefficient in the infrared wavelength used). The SensorBox is also implemented in a thermally controlled housing to prevent any overheating of the system during the warm season and freezing during cold season (see figure 6).

For the time being all measured data are backed up. Once they are on the storage server, post-processing at desired sub-sampling frequency can be made. The effect of the atmosphere is addressed through a transmission law that integrates environmental evolution with time. In the present paper, in a first approach, an average distance between the IR Detector and beams was taken to 20 meters (see figure 6) for the transmission evaluation with time.
