Influence of Moisture Content on Defect Detection by Active Thermography Method to Concrete Structure

by H.Kondou¹, M.Koyama¹, M.Ishikawa², H.Sasano³, H.Hatta⁴, S.Utsunomiya⁴, R.Hukui⁵, N.Ogasawara⁶

Abstract

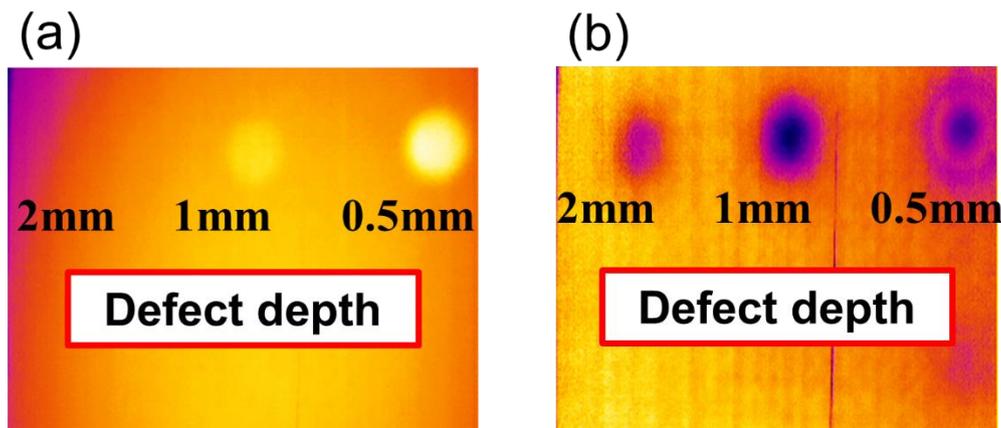
Fig.1 (a) Thermal image, and Phase image.

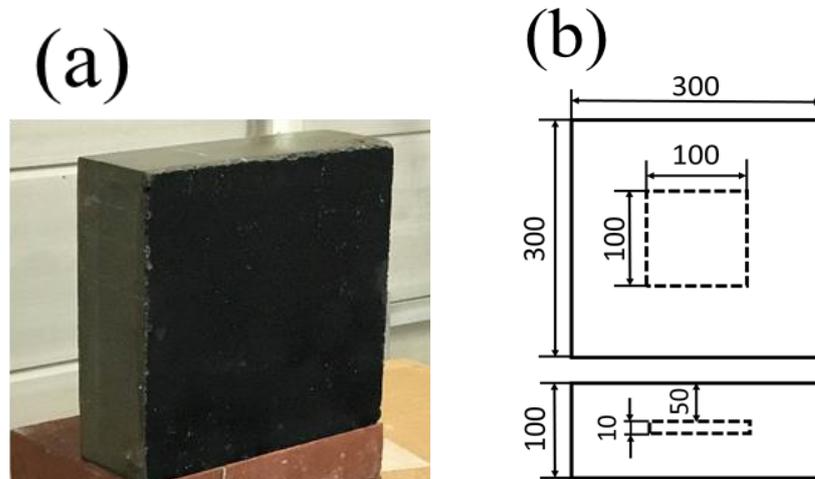
Fig.2 (a) Specimen image, and (b) Localizations of defects for specimen.

The test piece was 300 x 300 in size and 100 mm thick, with artificial defects inserted at a depth of 50 mm from the surface. Specimen images are presented in Figs.2 (a) and (b).-The test piece was weighed after heating and drying, and then immersed in water for a predetermined time so that the test piece contained moisture. As a result of weight measurement after the impregnation with water, the water content was 1.47, 10.99%. Water content was calculated at gravimetric water content.

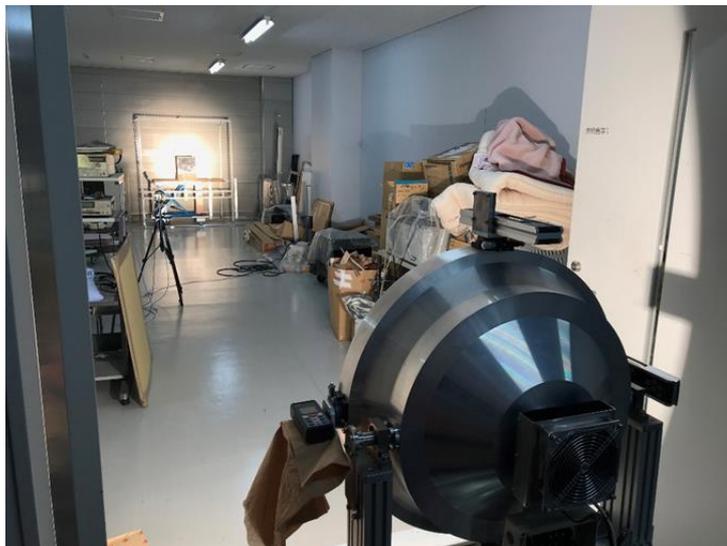
Fig.3 Experimental setup.

Experimental setup is presented in Fig.3. In the experiment, the sample surface was heated with a halogen lamp for 200 seconds, and the temperature distribution on the surface during heating and cooling was observed using an infrared camera (A320; FLIR Systems Inc.) at a sampling frequency of 1 Hz, Fig.4 (a) (b). The performance of the halogen lamp is presented in Table.1 and the power approximation performance curve is presented in Fig.5. Relationship between the maximum temperature difference and the total heat input on a 50 mm deep defect is presented in Fig.6. The inspection system used in the experiments was a Thermo Inspector (KJTD Co. Ltd.) [4].

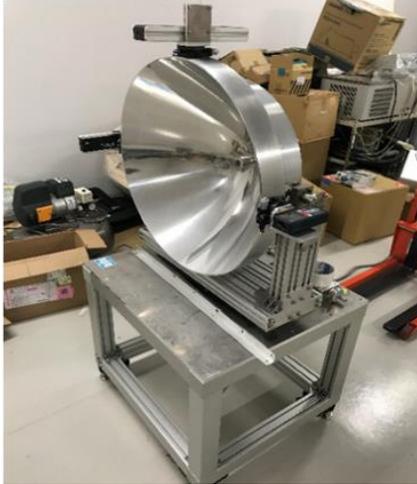
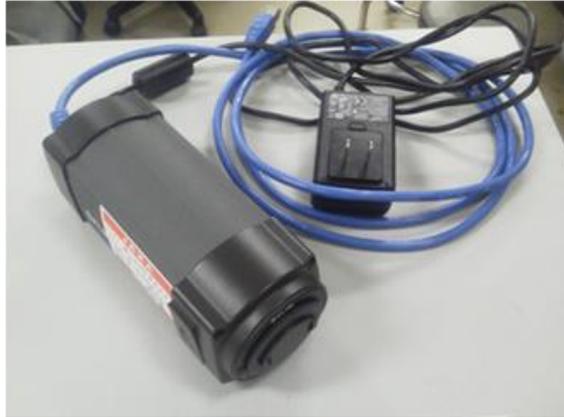
Fig.4 (a) Halogen lamp, and (b) Infrared camera (A320; FLIR Systems Inc).

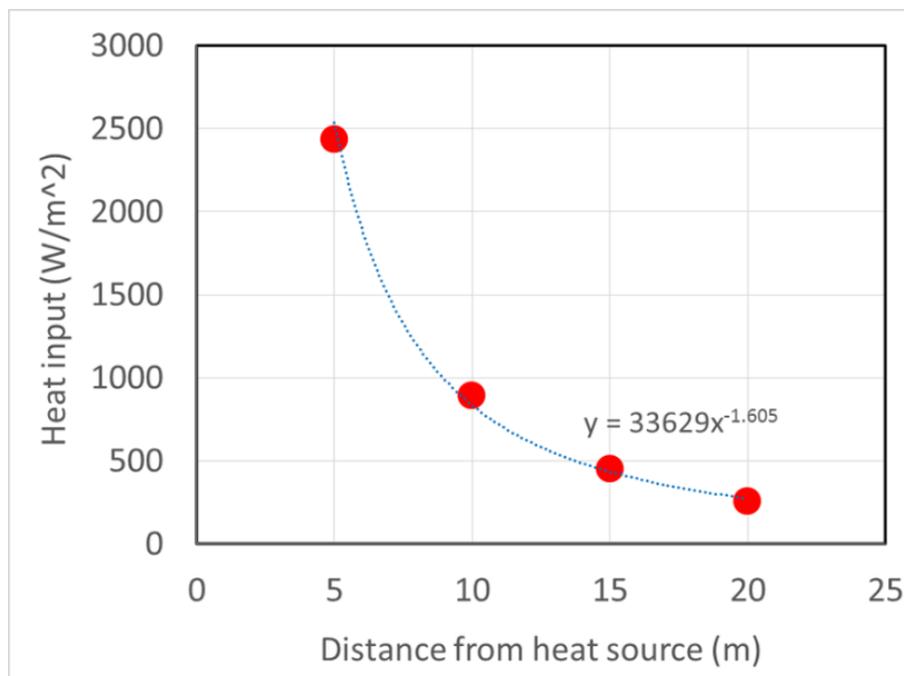
Fig.5 Power approximation performance curve.

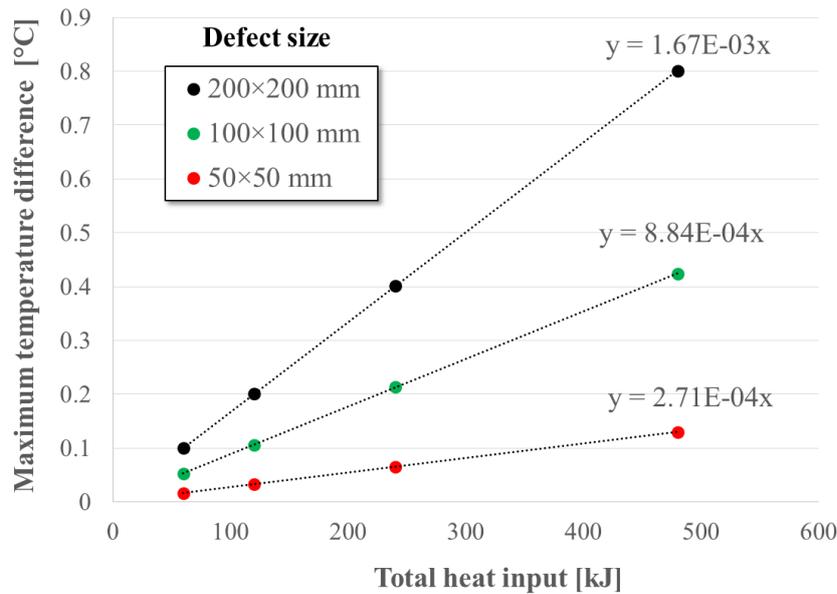
Fig.6 Relationship between the maximum temperature difference and the total heat input on a 50 mm deep defect.

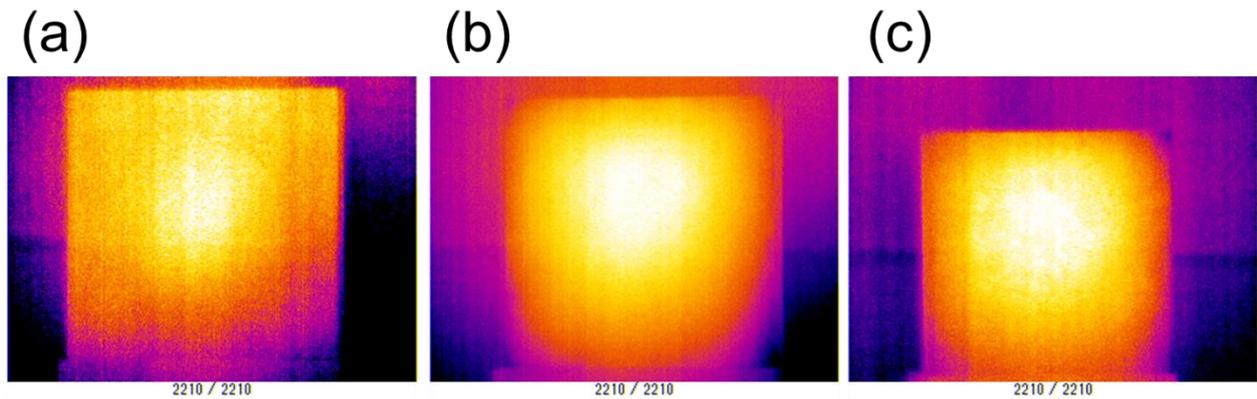
Fig.7 Thermal images obtained (a) No hydrous specimens, (b) water content 1.47%, and (c) water content 10.99%. Both are thermal images at 2210s from start heating.

Thermal images obtained are presented in Figs.7 (a), (b), and (c). The phase images obtained by Fourier transformation using thermal data are presented in Fig.8 (a), (b), and (c). Temperature difference between defective and non-defective areas on the defect with water contents are plotted in Fig.9. Temperature and phase images show that defects can be detected without being affected by moisture. And, it was confirmed that the temperature difference decreased with water content. It was confirmed that the temperature difference increased at the end of shooting compared to the dry state. Increase in temperature difference leads to improve in defect detection accuracy. The cause of this phenomenon is thought to be the change of the thermal conductivity and thermal diffusivity of concrete due to water content. As an index of thermal diffusivity, the heat given by the following Eq. (1) the thermal diffusivity α is used.

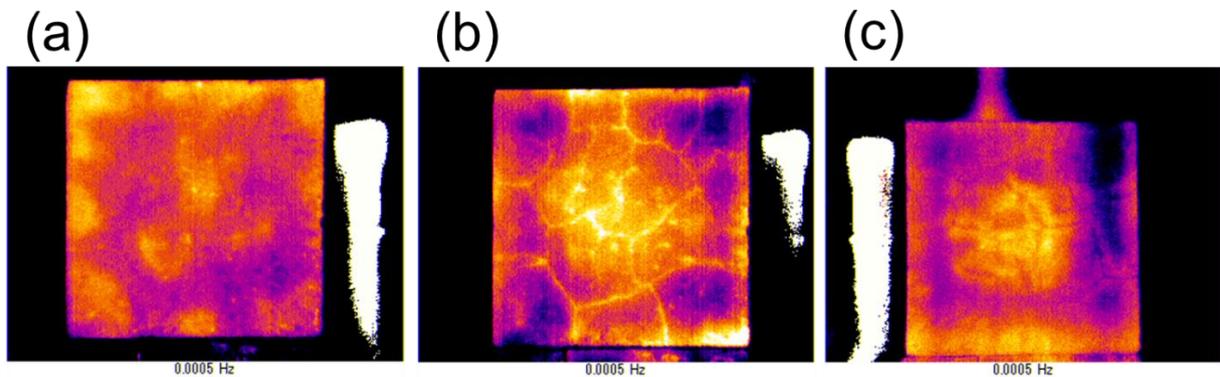
Fig.8 Phase images at frequency of 0.0005 Hz from thermal data obtained (a) No hydrous specimens, (b) water content 1.47%, and (c) water content 10.99%.

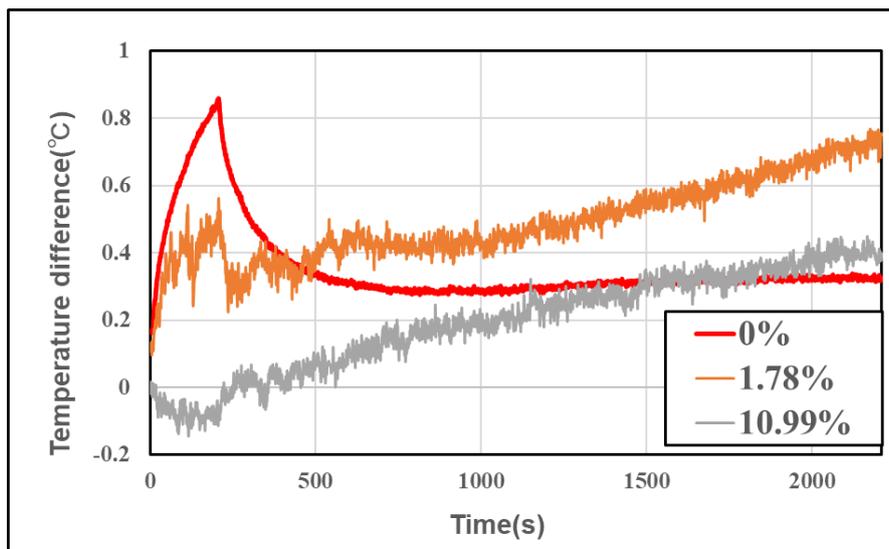
Fig.9 Experimental results observed temperature difference for no hydrous specimen, and water content 1.47, 10.99%.

In case of concrete physical property values ($\lambda=1.7(\text{W/mK})$, $\rho=2240(\text{kg/m}^3)$, $c=800(\text{J/kgK})$), $\alpha=0.95(\text{mm}^2/\text{s})$ is obtained. As well, in case of water physical property values ($\lambda=0.6(\text{W/mK})$, $\rho=998(\text{kg/m}^3)$, $c=4200(\text{J/kgK})$), $\alpha=0.14(\text{mm}^2/\text{s})$ is obtained. This calculation result shows that the heat transfer coefficient is reduced due to the inclusion of water. The reduction of the heat transfer coefficient hinders the heat transfer in the in-plane direction, and as a result, the temperature difference between the defective portion and the sound portion is reduced. It is considered that this phenomenon caused the decrease in defect detectability due to the water content. The details of the water content and thermal conductivity will need to be clarified by future experimental verification. From these results, it was suggested that the effect of moisture in concrete is an important issue when applying this inspection method to actual structures.
