Develop Sonic Infrared Imaging NDE for Quantitative Assessment on Damage in Aircraft Composite Structures

by X. Han*, S. Zhao**, D. Zhang*, A. Lubowicki*, L. Favro***, R. Thomas***, and G. Newaz**

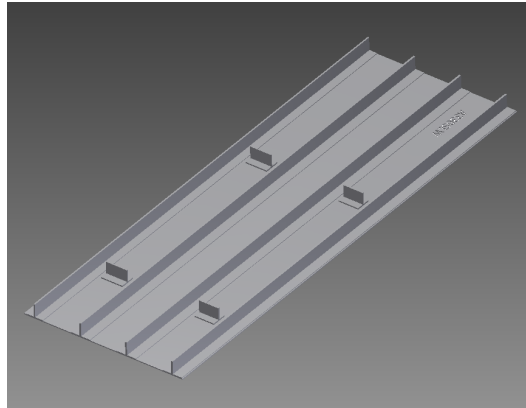
Fig. 1. 3D Drawing showing the backside of the A330 panel which has four stringers (ribs).

In Sonic IR Imaging, the major pieces of equipment are an ultrasound excitation system, which contains an ultrasound transducer, power/control components, a commercial infrared imager, electronic synchronization control unit, and a computer with image acquisition and image/data processing unit. Ultrasound excitation sources provide a low frequency ultrasound pulse, typically a fraction of a second, to the target to cause relative motion of the faces of defects and thus frictional heating is produced in the defects. The temperature gradient in the sample results in the spreading of heat from the defects to their vicinity governed by heat diffusion equation. As a result, the surface temperature over the sample may rise which can be mapped by the infrared imager. In our experimental set-up, the ultrasound excitation systems we have used are Branson 20kHz ultrasound welder, and the IR imager is a FLIR commercial mid-IR camera. The number of the camera pixels and the size of the imaged area determine the spatial resolution of the details. The sample we used for this study is an A330 vertical stabilizer simulation panel. Figure 1 is a 3D drawing that shows the backside structure of the panel with four stringers (ribs). The panel is 162 cm x 58 cm. The thickness of its skin is 0.41 cm and that over the stringers is 0.53 cm. The adjacent stringers are about 16.5 cm apart. In addition, the panel also has four stiffeners as shown, and two of them contain disbonds. As seen in the drawing, they are located in two "channels" formed by two stringers. Each pair of the stiffeners is 70 cm apart.

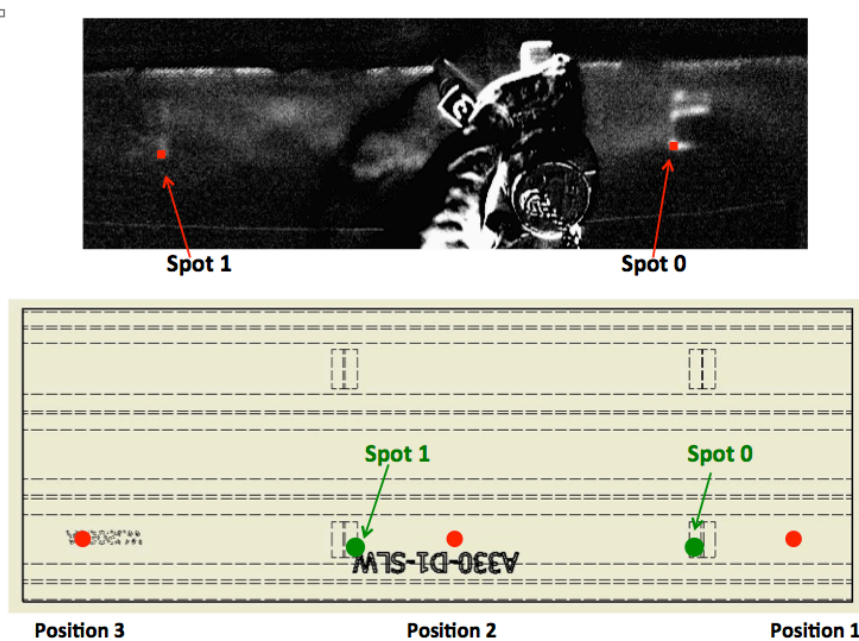
Fig. 3. Drawing indicates the three locations where a 20kHz ultrasound transducer was put relative to the disbonded stiffeners labeled as “Spot 0” and “Spot 1”.

Based on the results shown above, further study was carried out. We set the sound pulse to 0.8s in the experiments. This pulse length is relatively long compare to a typical pulse used in metal structures. This is due to the attenuation of the sound propagation in composites. In Figure 3, an IR image presents the disbonded stiffeners marked as "Spot 0" and "Spot 1". In the same figure, also presented is a drawing showing the positions of the disbonded stiffeners at "Spot 0" and "Spot 1" with green spots. Meanwhile, three red spots labeled as position 1, 2, and 3 are the positions at which a 20kHz ultrasound transducer was put to induce the ultrasound pulse for different experiments respectively. This study is to aim at the understanding of the effect of the structures and the relative positions of the sound source and the defect with quantitative measurement of the IR signal levels at the two spots with different sound source locations. Position 1 is 20 cm away from "spot 0" to its right, and 90 cm away from "Spot 1" to its right; Position 2 is 50 cm away from "spot 0" to its left, and 20 cm away from "Spot 1" to its right; Position 3 is 119 cm from "spot 0" to its left, and 50 cm away from "Spot 1" to its left. Please note that "Spot 0" and "spot 1" are 70 cm apart. The relative locations between the ultrasound source positions and the stiffeners are listed in Table 1. At each position of the sound source, the IR contrast signal levels for "Spot 0" and "Spot 1" resulted from a 3x3 pixel average are plotted for comparison, which represent the difference of IR radiation between the region of interest and the background region as a reference. All the IR signals were obtained at thirty frames per second for total of 10 seconds since the low diffusivity

Table 1. Relative locations between the ultrasound source positions and the stiffeners

Position 1	Position 2	Position 3
Spot 0	Relative Distance	20 cm	50 cm (Left)	120 cm (Left)
	Max IR contrast	49	22	3
Spot 1	Relative Distance	90 cm	20 cm	50 cm (Left)
	Max IR contrast	7	38	16
