## Passive thermography for delamination detection in GFRP of Wind Turbine Blade

by Lucas REOCREUX<sup>a,b</sup>, Zhewei YU<sup>b</sup>, Sébastien ARNOULD<sup>b</sup>, and Hervé PRON<sup>a</sup>

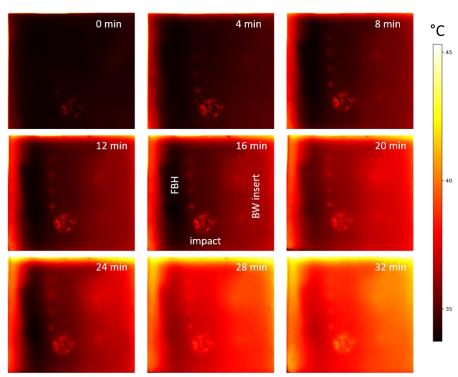
Fig. 1: Thermograms taken of the sample exposed to the sunshine from 0 to 32 minutes. The sample presents a surface impact, 2 BW inserts at 10 and 7 mm from bottom to top, as well as 4 flat bottom holes (FBHs) with depth 3, 5, 8 and 10 mm from bottom to top.

The experimental test was carried out using a cut piece of a blade with 2 BW inserts with 20 mm in diameter 7, 10 mm in depth as well as 4 flat bottom holes (FBHs) with 20 mm in diameter and 3, 5, 8, 10 mm in depth. An impact damage is also presented in the front surface of the sample. At the beginning of the test, this sample was moved from inside (room temperature at 25 °C) to outside under the sun irradiation. The thermograms were taken routinely every 4 minutes from 0 to 32 minutes. The result (Fig. 1) shows that the less deep defects, the 3 mm FBH and the 7 mm BW insert can be observed easily at early time, which is about 5 minutes. The deeper ones, on the other hand, can be only observed afterwards. However, the maximal thermal contrasts for these defects are generally achieved around 15 minutes, despite the nature, the size or the depth of the delamination defect.
