## Characterizing complex metal-CFRP-hybrid structures by thermography

by M. Schwarz<sup>a,b</sup>, A. Hell<sup>a</sup> and H.-G. Herrmann<sup>a,b</sup>

In this paper results of non-destructive testing of metal-CFRP-hybrid structures are shown. The hybrid samples vary from 2D to 3D geometry. As NDT-method active thermography with its excitation modes flash and induction through an eddy current coil are used. It is shown that artificial induced defects like pleats in the CFRP-layer and mechanically induced delaminations at the interface CFRP/thermoplastic can be detected. For the latter defect, a different damage behavior can be shown depending on the geometry.

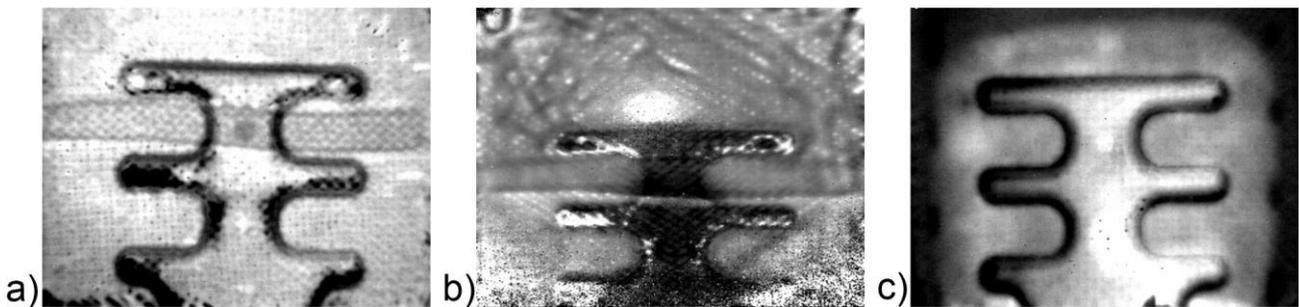
**Fig. 1.** Thermography images of a 2D-sample with a) a pleat in the second CFRP-layer, excitation with flash, b) inductive excitation and c) sample with a mechanically induced delamination

Thermography results in figure 1 show that artificial induced defects like a pleat between the first and second layer can be detected with flash excitation as well as with inductive excitation. Additional the aluminum inlay and the fiber

orientation in the first layer can be shown. Besides artificial defects, real defects that occur during mechanical testing are characterized in figure 1 c). It can be seen that around the aluminum there is a bright area which represents a delamination of CFRP from thermoplastic.

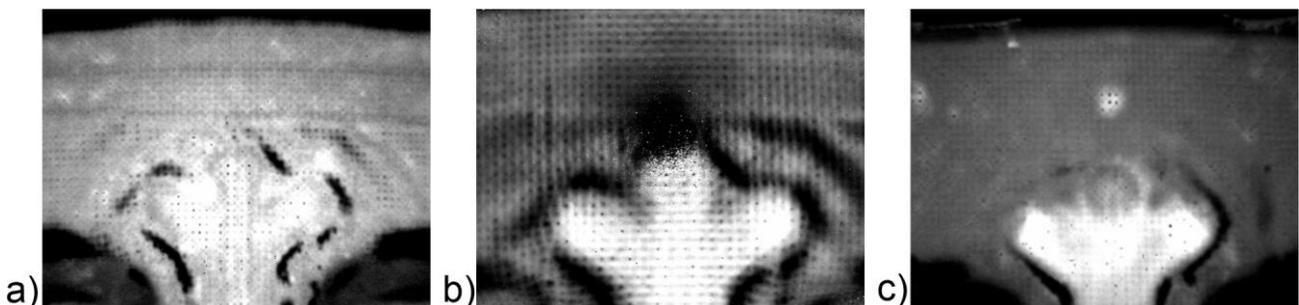
**Fig. 2.** Thermography images of a 3D-sample with a) a pleat in the second CFRP-layer - excitation with flash, b) inductive excitation and c) sample with a mechanically induced delamination

In contrast to the 2D-structure the 3D-hybrid has a curved CFRP-layer and a bent metal inlay. Figure 2 shows thermography images of this 3D-hybrid structure. Figure 2 a) and b) show a sample with a pleat between the first and second CFRP-layer. The pleat can clearly be seen above the metal inlay in the flash image as well as in the inductive image. Besides the pleat, the fiber orientation in the first layer and the metal inlay can be detected. Figure 2 c) shows a 3D-sample after mechanical testing. In the area of the metal inlay a bright area can be detected which can be interpreted as delamination.
